eXceed Aligners Case Presentation

August 21, 2016

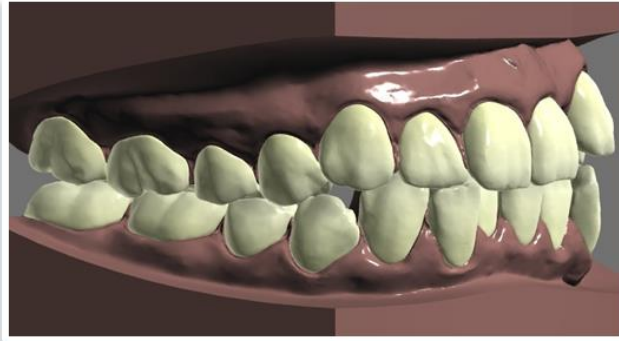
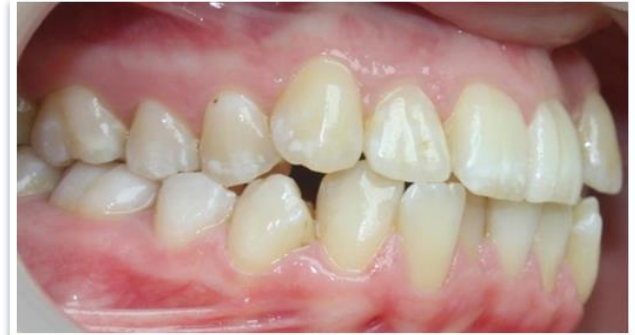
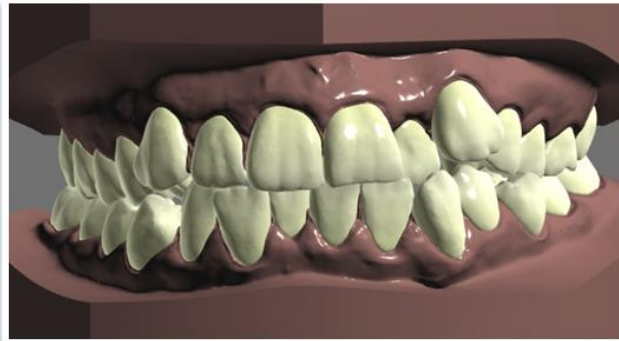
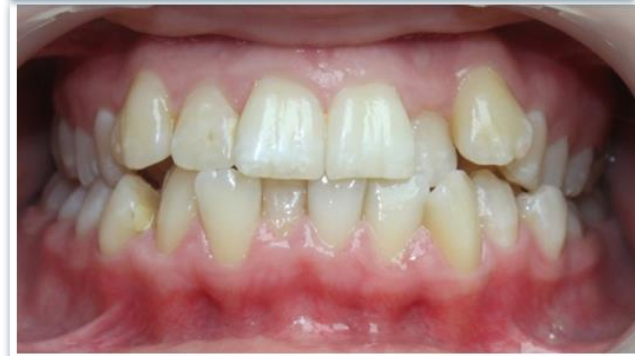
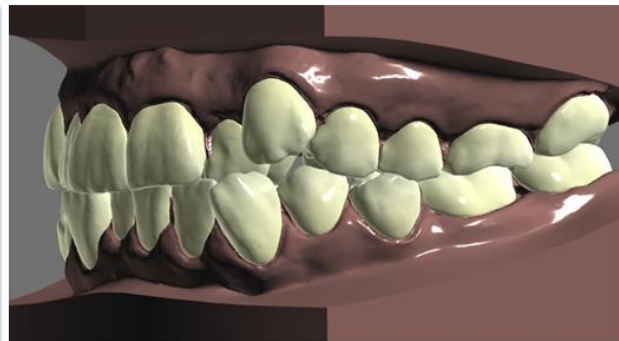
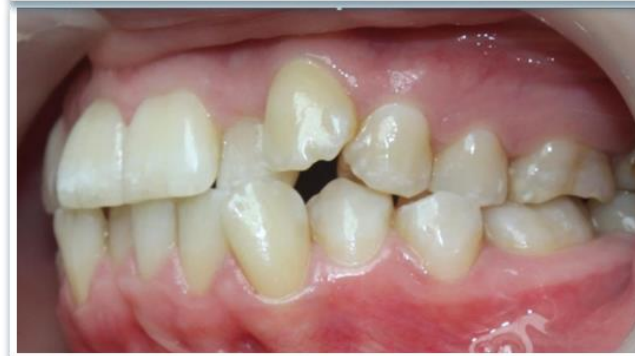
Pre-Treatment 3D models and intra-oral images

Diagnosis: Skeltal class I, (Class III tendency), Dental Class I mild-moderate crowding. Minimal Overjet and Overbite. Upper midline 1 mm to Left. Lower midline 1mm to Right. Cross bite 14,22,25. Palataly positioned 22. 12/42 Tete-a-Tete. Blocked out-high 23, Rotated 33. Mesially inclined, impacted 18. Good oral hygiene and healthy gums.

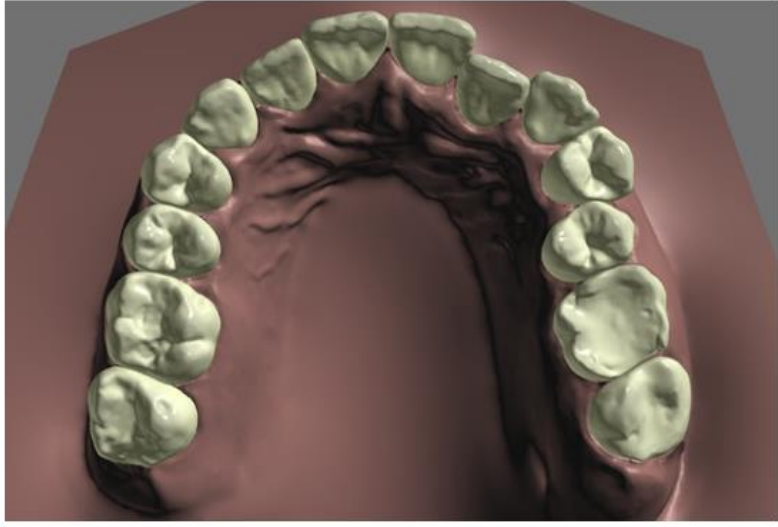
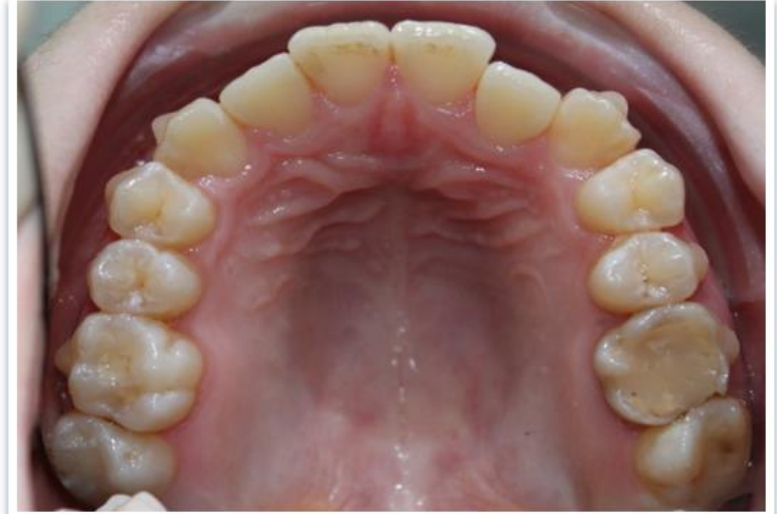
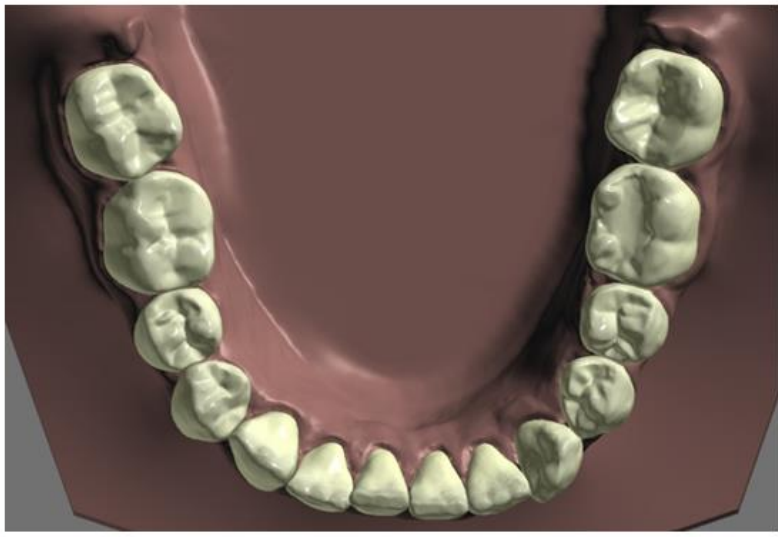
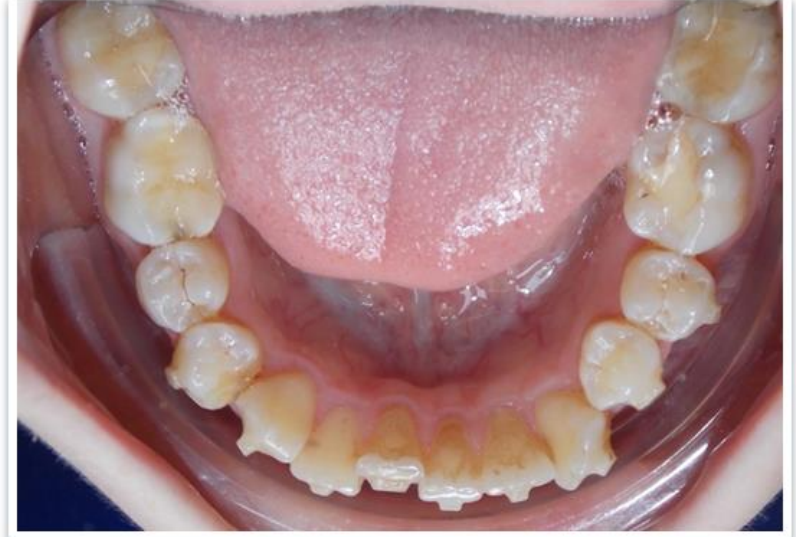
Pre-Treatment – Occlusal View

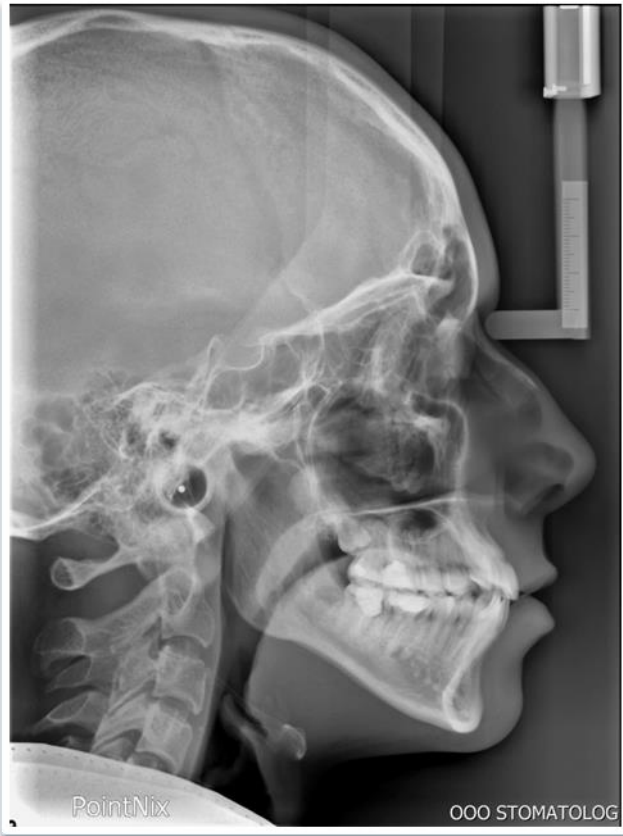
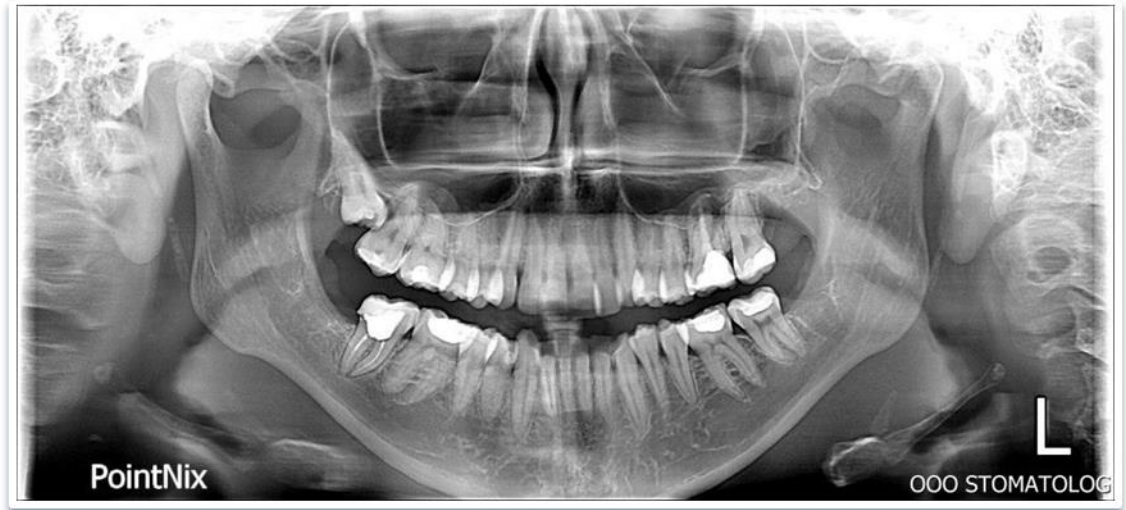
Pre-Treatment Lateral Ceph and Panorex

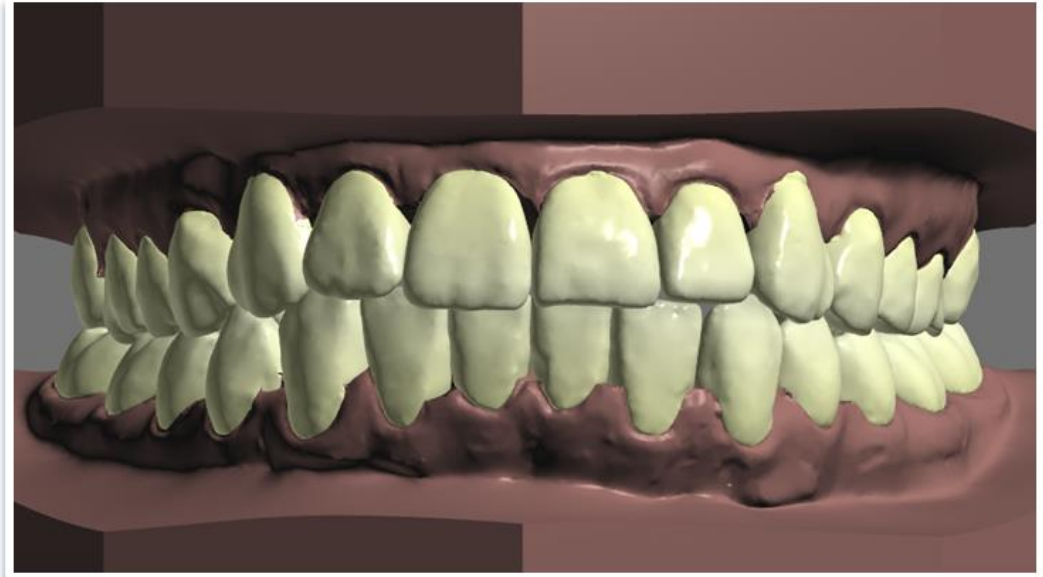
Post Treatment – Frontal View

Virtual Outcome –
03.2014

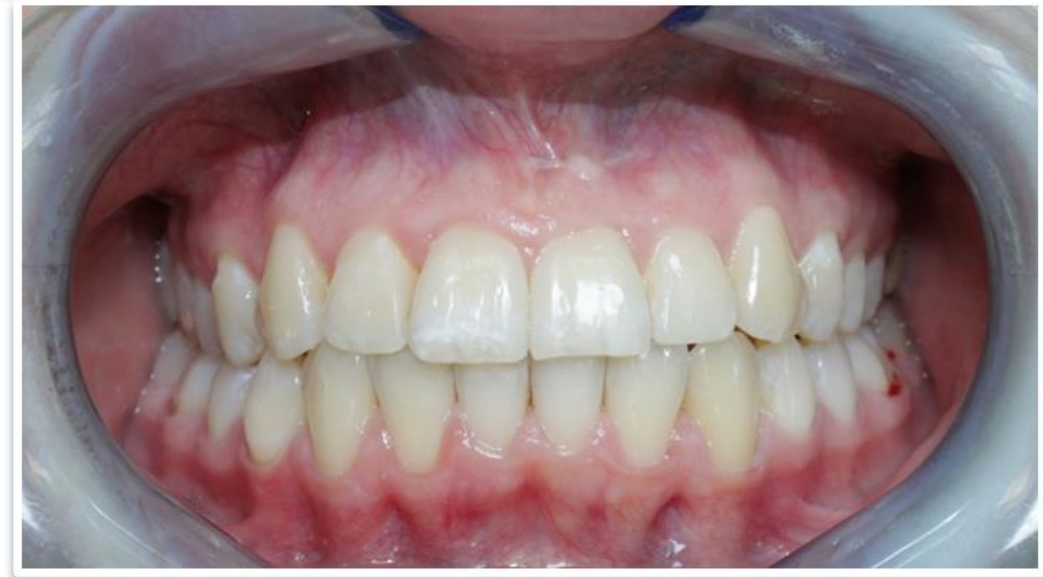
Actual Outcome –
11.2015

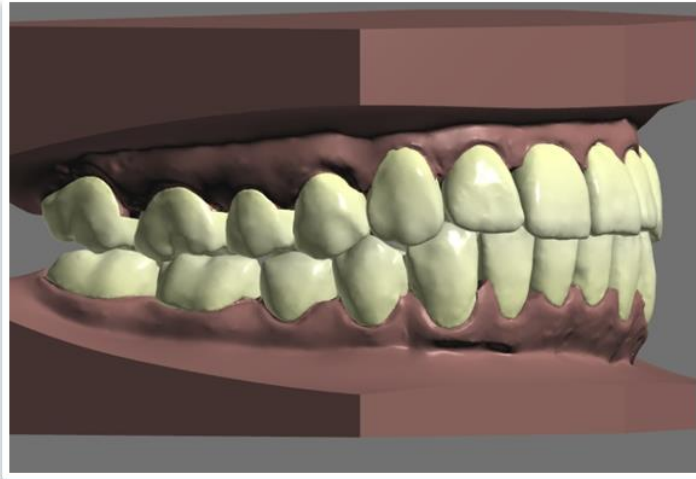
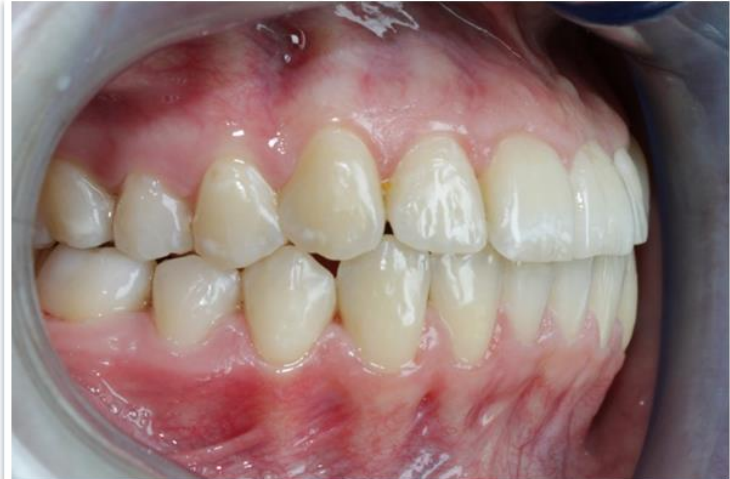
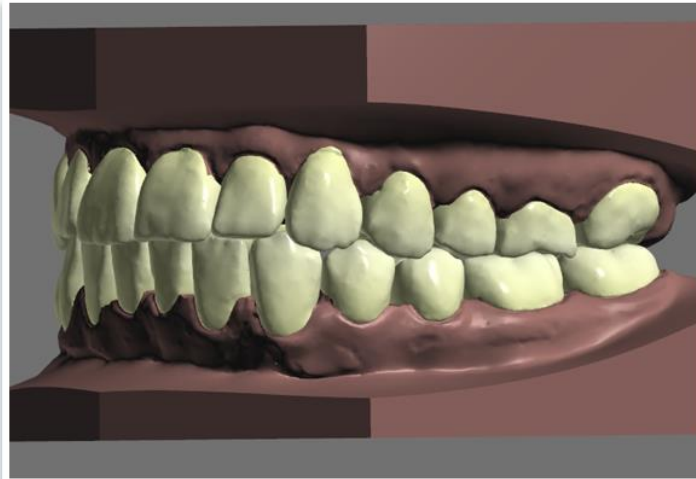
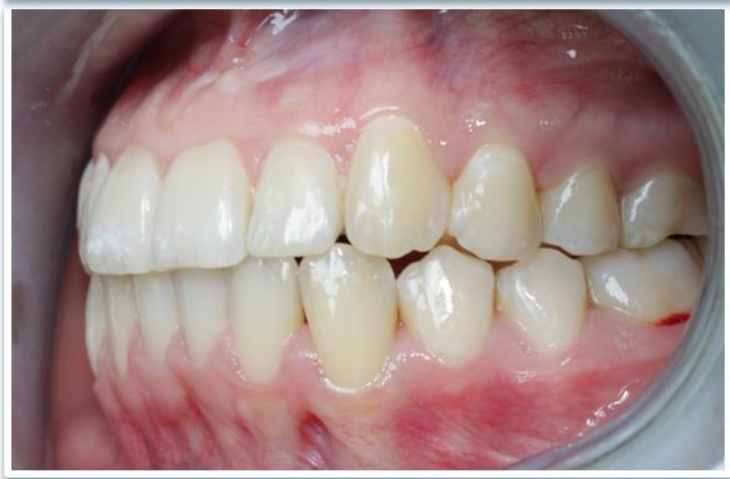
Post Treatment – Side View

Virtual Outcome – 03.2014

Actual Outcome – 11.2015

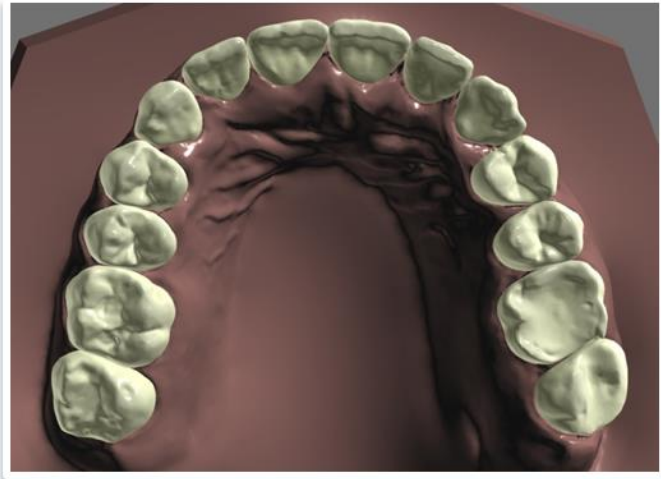
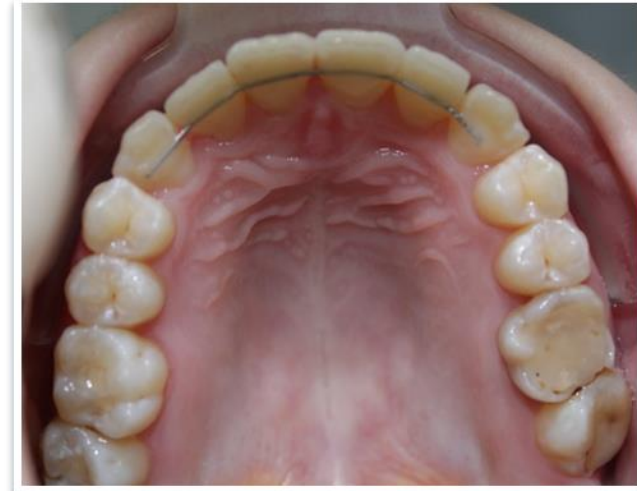
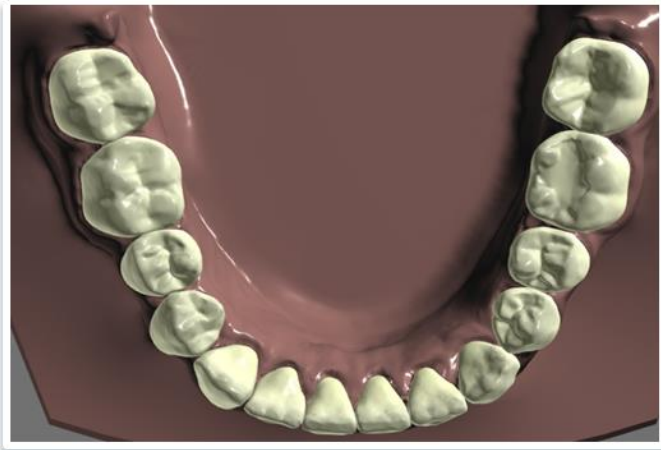
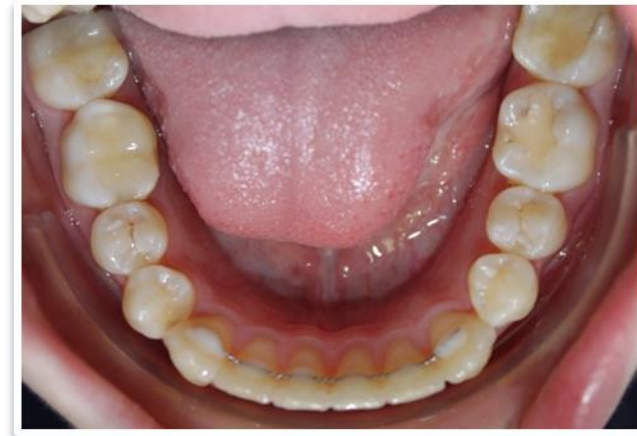
Post Treatment – Occlusal View

Virtual Outcome – 03.2014

Actual Outcome – 11.2015
